Freezing Winter Storm Grayson Takes South Carolina's Infrastructure And Response Effort To The Bursting Point

A BREAK UNLIKE ANY OTHER

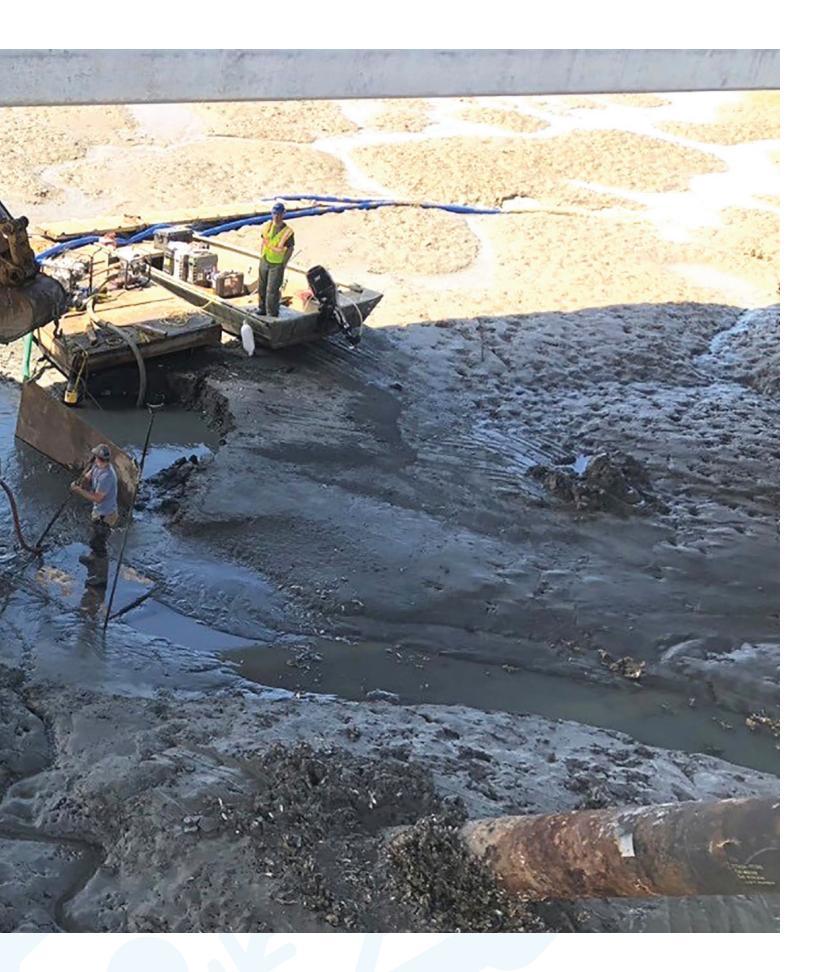
The waterline was buried deep in saltmarsh. Over the years, as the marsh mud had shifted, this section of the line had become exposed to the environment. As a result, the bolts holding the restrained joints together had rusted and failed.

The group made emergency repairs to reduce the leak from 200 gallons-perminute to 20...

Georgia. The group made emergency repairs to reduce the leak from 200 GPM to less than 20 GPM by replacing the failed bolts. To stop the leak completely, a special repair sleeve was designed and installed sixty days after the emergency repair. The total cost of the repair effort was over \$90,000-with 90% of the amount covering such unusual expenses as barges and divers.
