Freezing Winter Storm Grayson Takes South Carolina's Infrastructure And Response Effort To The Bursting Point

A BREAK UNLIKE ANY OTHER

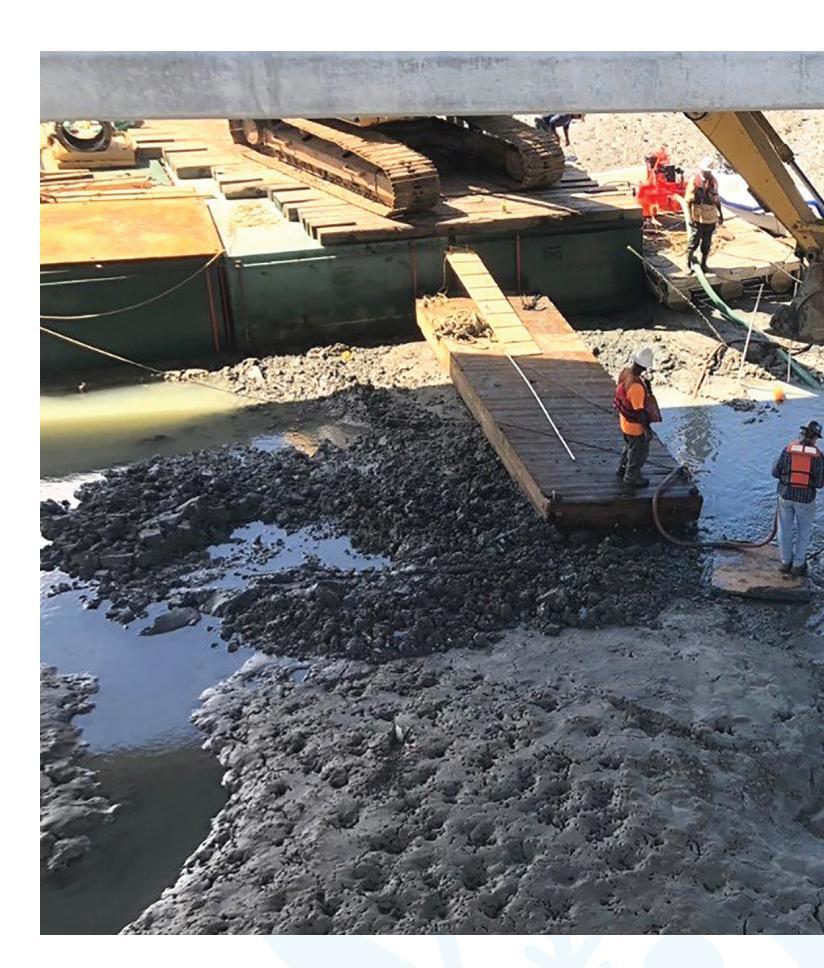
It was not until low tide that Mattie and Throne saw the origin of the running water: a major 200 gallon-per-minute (GPM) leak on the twenty-inch waterline that coursed through the saltwater marsh adjacent to the bridge approach from Lady's Island.

Installed in 1992, this critical supply line involved twin twelve-inch lines attached to the bridge that connected to a twenty-inch mainline buried in the marshes. The waterline was critical to water operations for 9,400 customers on the Lady's, St. Helena, Dataw, Fripp, and Cat Islands. Without it, the service area would not be able to meet minimum service standards. Crews

The line's leaky fitting was very near piles that had been constructed during an expansion of the McTeer Bridge. The area around these piles had a tidal fluctuation of more than eight feet two times per day. Investigation suggested that the change in the river flow that the new piles had caused, had most likely eroded the cover over the pipe.

determined that the leak was controllable and established protocols for its periodical inspection while a repair plan was developed.

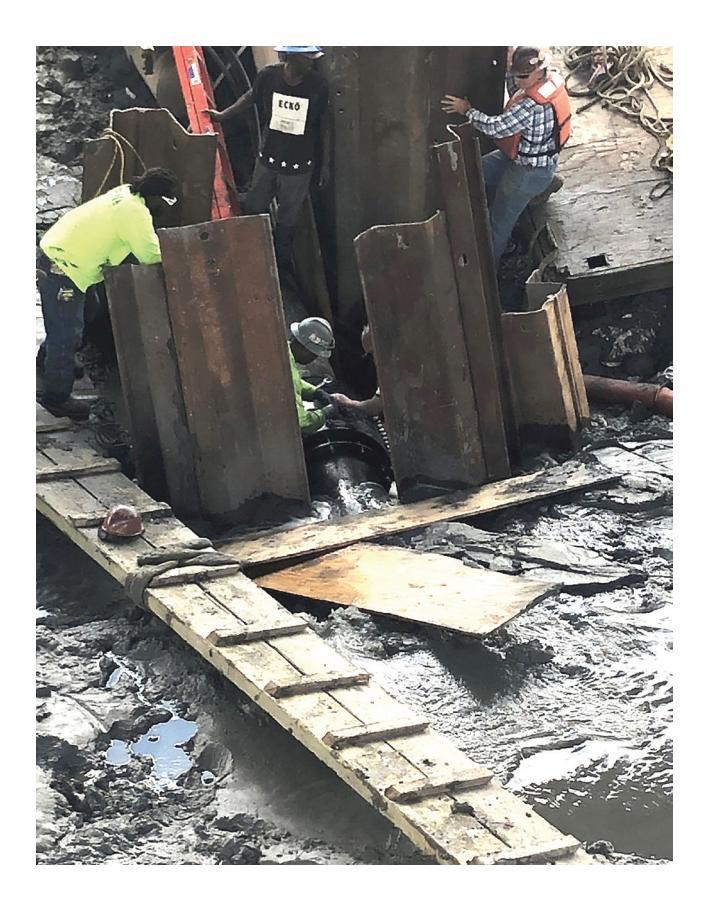
The waterline was buried deep in saltmarsh. Over the years, as the marsh mud had shifted, this section of the line had become exposed to the environment. As a result, the bolts holding the restrained joints together had rusted and failed.

B&V subcontracted with Structural Integrity Associates (SIA) to perform guided wave testing (GWT) and B-scan ultrasonic surveys

and analyses. GWT is an ultrasonic method that directs sound along the length of the pipe using G-scan equipment. The GWT system is a lowfrequency ultrasonic guided wave technique that detects internal and external corrosion. Ultrasonic methods provide data regarding the interior and exterior corrosion of a pipe as well as actual condition data.
